# **Hassen Memorial Arena**

**Armstrong, B.C**

## **Mechanical Assessment Report**

**11 November 2024**

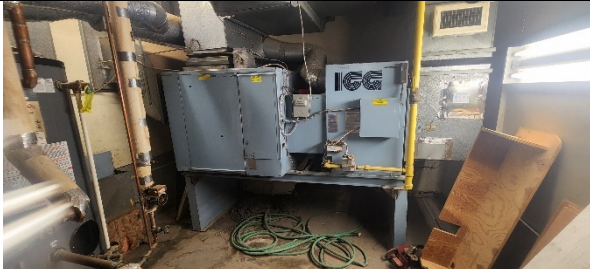
| | <p>Observations:</p> <ul style="list-style-type: none"><li>◆ Existing gas fired Make-Up Air unit tagged AMU-1 provides heating and ventilation to the lower floor level Washrooms, Change Rooms and Snack/Storage Room. No cooling or additional back-up heat has been observed.</li><li>◆ Remote programmable thermostat located in the Women Washroom. Currently set to 14.5 Deg C room temperature but user adjustable.</li></ul> |

| | <p>Recommendations:</p> <ul style="list-style-type: none"><li>◆ Unit is approaching its end-of-life service and recommend sourcing replacement soon.</li><li>◆ Option 1: Replace as per original unit specifications if future maintenance parts availability is generally not an issue. Energy consumption would remain the same at roughly 80% efficiency.</li><li>◆ Option 2: Replace with condensing type at least 90% high efficiency unit for energy use reduction. Modifications to the common breeching vent maybe required as this unit would be vented separately.</li></ul> |

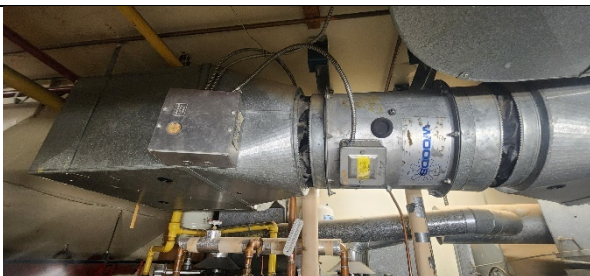
| | <p>Observations:</p> <ul style="list-style-type: none"><li>◆ Existing Exhaust Fan appears to be in good condition although controlled with a manual timer switch in the Mechanical Room. No outdoor air ventilation to the space unless manually activated.</li></ul> <p>Recommendations:</p> <ul style="list-style-type: none"><li>◆ Convert to automated control function to cycle dampers with make-up air unit.</li></ul> |
| | <p>Existing control system overview:</p> <ul style="list-style-type: none"><li>◆ Based on air balancing report submitted by Inland Technical Services, AMU-1 control dampers remained open and did not change positions when exhaust fan was manually activated during balancing. This would indicate AMU-1 is constantly on full recirculation mode even with the Exhaust Fan operational.</li></ul> |

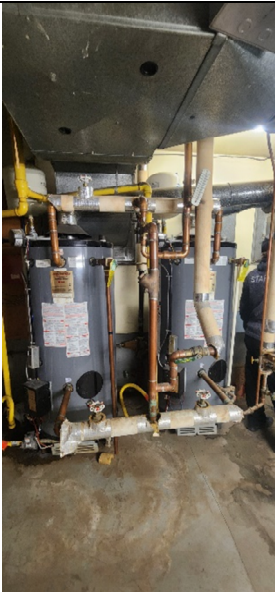
| | <p>Observations:</p> <ul style="list-style-type: none"> <li>◆ Existing domestic water heaters are atmospheric type with a common breeching vent with AMU-1. These were manufactured in 2014 with a life span up to 15 years depending on maintenance and water quality.</li> <li>◆ Missing domestic hot water piping insulation.</li> </ul> |

| | <p>Recommendations:</p> <ul style="list-style-type: none"> <li>◆ If the AMU should be replaced with a high efficiency unit, then consider replacing these as well to improve energy consumption in the long run. Remove common breeching vent and install sealed combustion PVC vents for each equipment.</li> <li>◆ Complete thermal pipe insulation to minimize heat losses to the system.</li> </ul> |

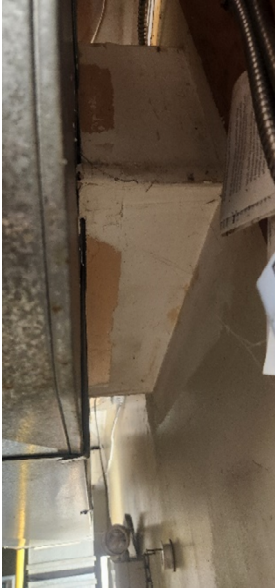
| | <p>Observations:</p> <ul style="list-style-type: none"> <li>◆ Grille penetrations from Mechanical Room to adjacent Washrooms does not appear to be provided with fire damper separation and duct branch shrouded with drywall flush to duct main. The room is fire rated with fire dampers observed in other penetrations through wall.</li> </ul> |

| | <p>Recommendations:</p> <ul style="list-style-type: none"> <li>◆ Site verify and confirm behind the grilles presence of a fire damper. Otherwise, replace grilles complete with combination balancing and fire damper for code compliance. Verify all duct penetrations fire damper are in good condition and tested.</li> </ul> |
